**MASSACHUSETTS INSTITUTE OF TECHNOLOGY  
HAYSTACK OBSERVATORY**

February 10, 2023

Subject: Mark6 expansion chassis power supply issue: detection and repair

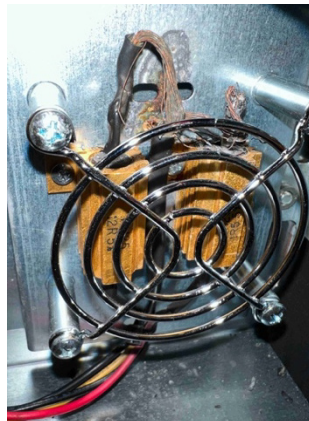
Unfortunately, inspection of some expansion chassis wiring of systems used by the Event Horizon Telescope (EHT) in the field has shown that the insulation of the wires can overheat, leading to wire exposure and fraying of the wires connected to the resistors (Figure 1).

*Figure 1: Example of overheated and frayed expansion chassis load wires.*

Conduant has since indicated that resistor heating was naturally expected, but that wire insulation breakdown was not. They believe that the root cause of the overheating and fraying of the wire

insulation—of mostly the wires to ground (GND) above the resistors—is primarily due to heat created by the two resistors, and specifically by the heat conducted through the copper wire that was routed between the resistors. That heat conduction is baking the sheathing. The current (~3 amperes) through the wire is well within its rated capacity.

1. Visually inspect your Mark6 expansion chassis (see instructions below).
2. If the wire insulation appears to be overheated or burned and the wires are frayed, there are two options:
  - a. Make the modification (described below) to the wiring on site *or*
  - b. Send the unit to Conduant to have them repair it.
3. If there is no apparent damage, MIT Haystack still strongly suggests that you make this modification as soon as time is available.

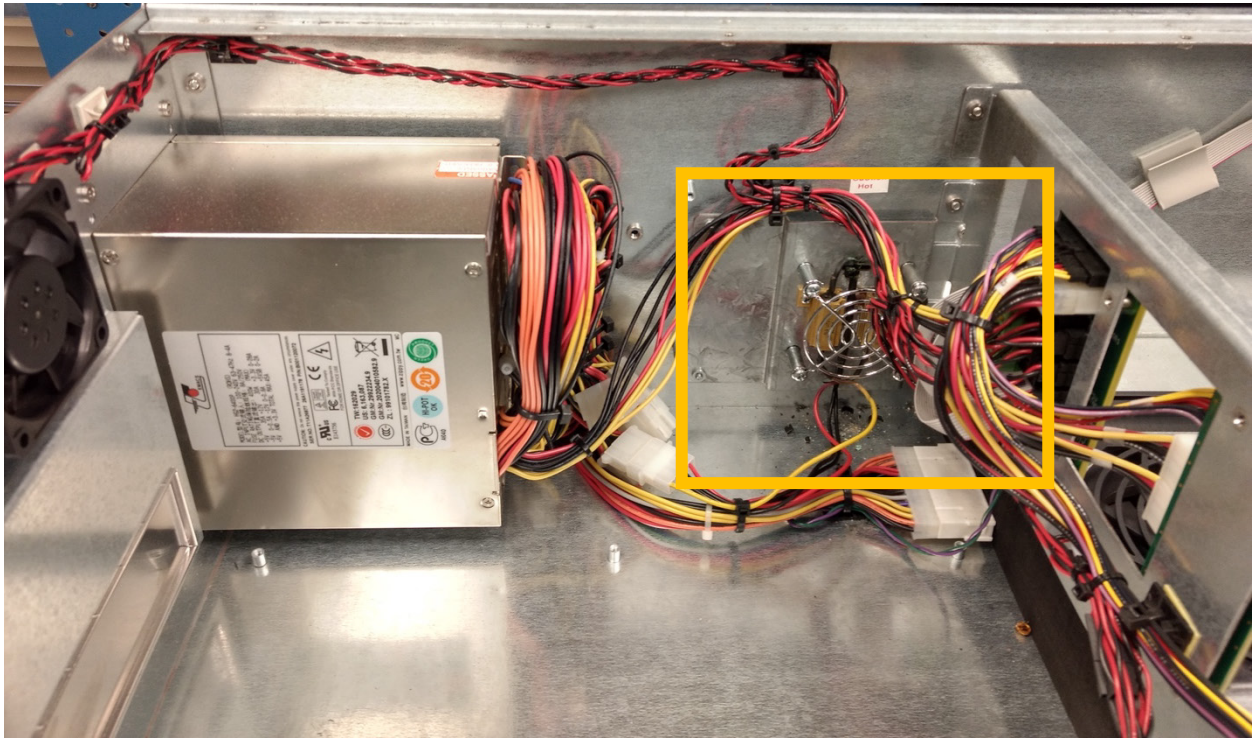
Figure 2: Expansion chassis resistor load location.

Carefully extract the Mark6 expansion chassis from the rack, noting all cable locations, and then remove the screws in the cover. The resistor load is located on the same side as the power supply and is mounted onto the side of the chassis (Figure 2).

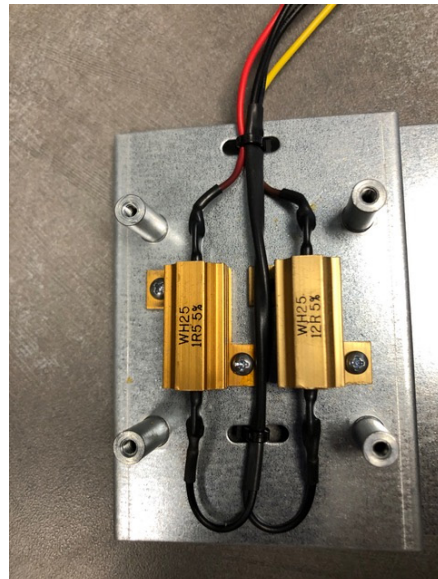
Figure 3: Original routing of shunt wiring.

The original routing of the wires (Figure 3) has the wires routed through the two resistors. The new routing includes moving the black ground wires to the left of the resistors (Figure 4).
