**MASSACHUSETTS INSTITUTE OF TECHNOLOGY
HAYSTACK OBSERVATORY
WESTFORD, MASSACHUSETTS 01886**

Subject: Reconnaissance of Skull Creek Reservoir area located in Catlow Valley, Oregon.

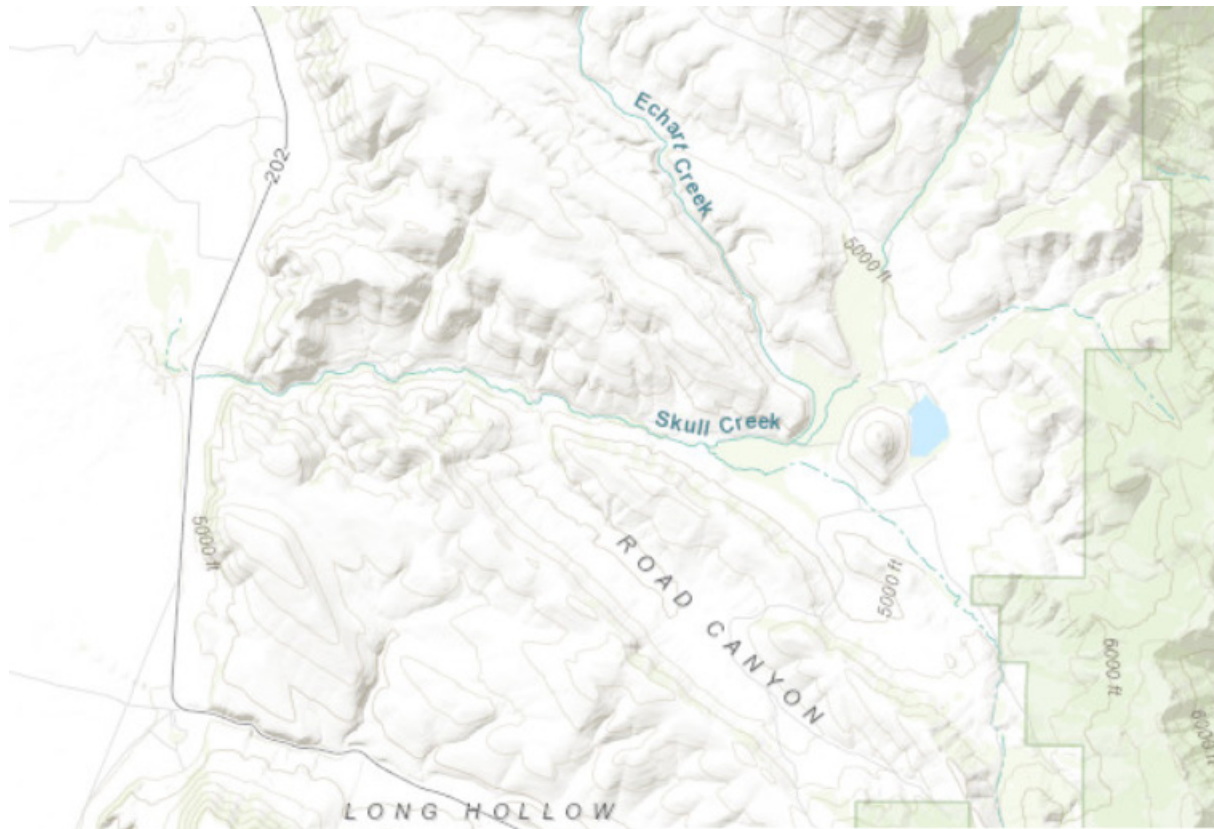
Figure 1. Skull Creek area in Catlow valley.

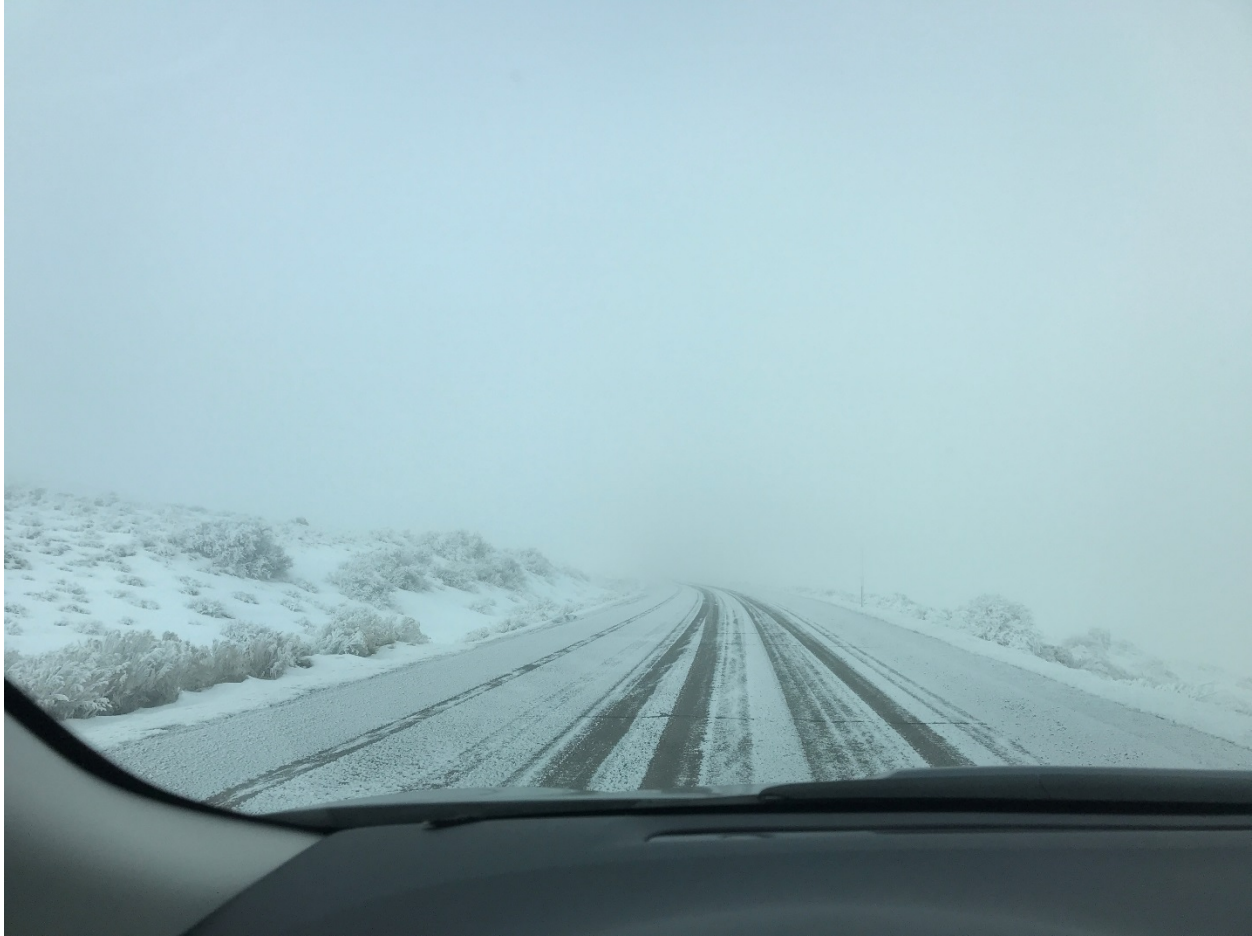
Upon arrival at Fields, a trial run to Roaring Springs Ranch before the scheduled meeting with Ranch staff the next day was conducted. The route was along the Catlow Valley road, also known as Route 202. Road conditions were fine until arrival at Long Hollow summit where conditions rapidly deteriorated.

Figure 2. Long Hollow summit where conditions rapidly deteriorated.

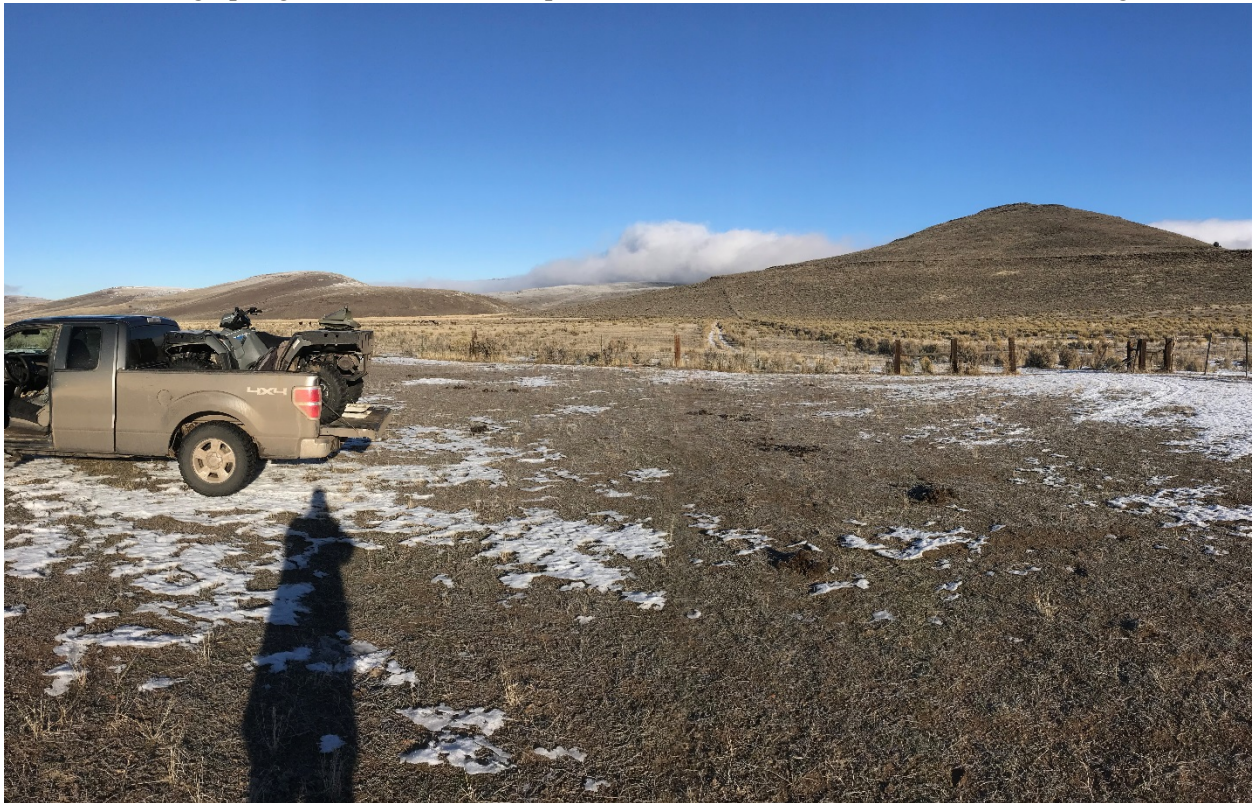
The area of interest at Skull Creek is about 5 miles from the gate. There were three locations that were to be evaluated based on the viewing of Geographic Information System software. We proceeded to the primary area of interest, later determined to be called the “branding area”. This is an area located on the South-South west of the Skull Creek reservoir area (42.387056, -118.761454). It is flat, surrounded by a barbed wire fence. The nearest hill is located about 0.5 miles away to the Northeast with the peak about 11 degrees above the horizon (Figure 3). The hill is the highest elevation obstruction, everything else is below 11 degrees. There is a farmhouse located on the other side of the hill unoccupied except for visits from the Roaring Springs Ranch owners. The power lines are about 0.6 miles from the branding area.

Figure 3. Branding area with Northeast peak, hill, about 11 degrees above the horizon.

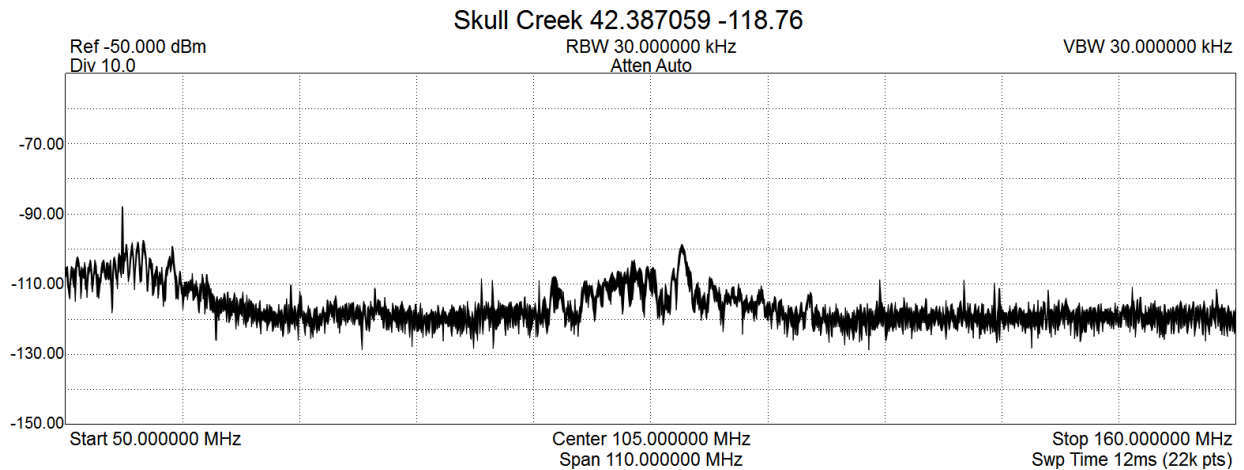
The Signal Hound and antenna were set up and spectra taken (Figure 4.). Due to the temperatures, in the teens and power draw of the Signal Hound, the measurement capability was limited. After the spectrum data was taken we assembled the directional antenna with a Wideband receiver and traveled to the other potential sites monitoring the power lines with the receiver set to the AM band. No power line interference was detected with either the system brought from Haystack nor the system that Andrew brought, an antenna tuned to 160 MHz.

Figure 4. Skull creek branding area spectrum.

After returning to the Alvord Inn the spectrum data was sent to Alan where he immediately detected an issue, misinterpreted by myself, at both the low and midband of the data. Once the laptop batteries were recharged the system was setup outside the Inn and spectrum taken. It appears that the USB GPS receiver, taken to get accurate position data was a source of RFI. This data was sent to Alan and after reviewed the plan was to head back to the site the next morning.

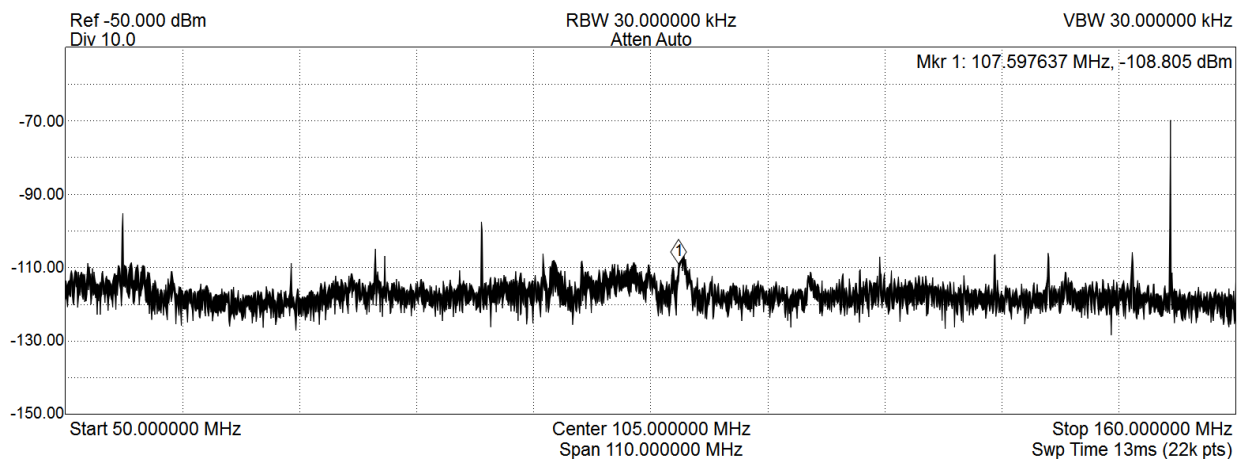
Figure 5. Fields Alvord Inn with USB GPS.

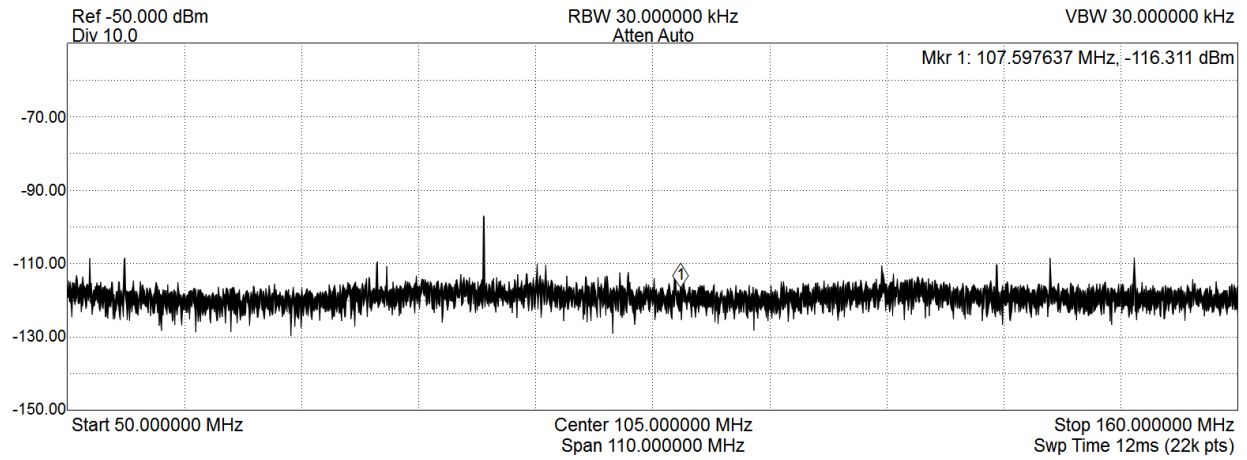
Figure 6. Fields Alvord Inn without USB GPS.
